## Weston Solutions, Inc.

**DOCUMENT CONTROL NO: RST3-02-F-0127**

SUBJECT: STRUCTURAL EVALUATION - NIAGARA FALLS BOULEVARD SITE

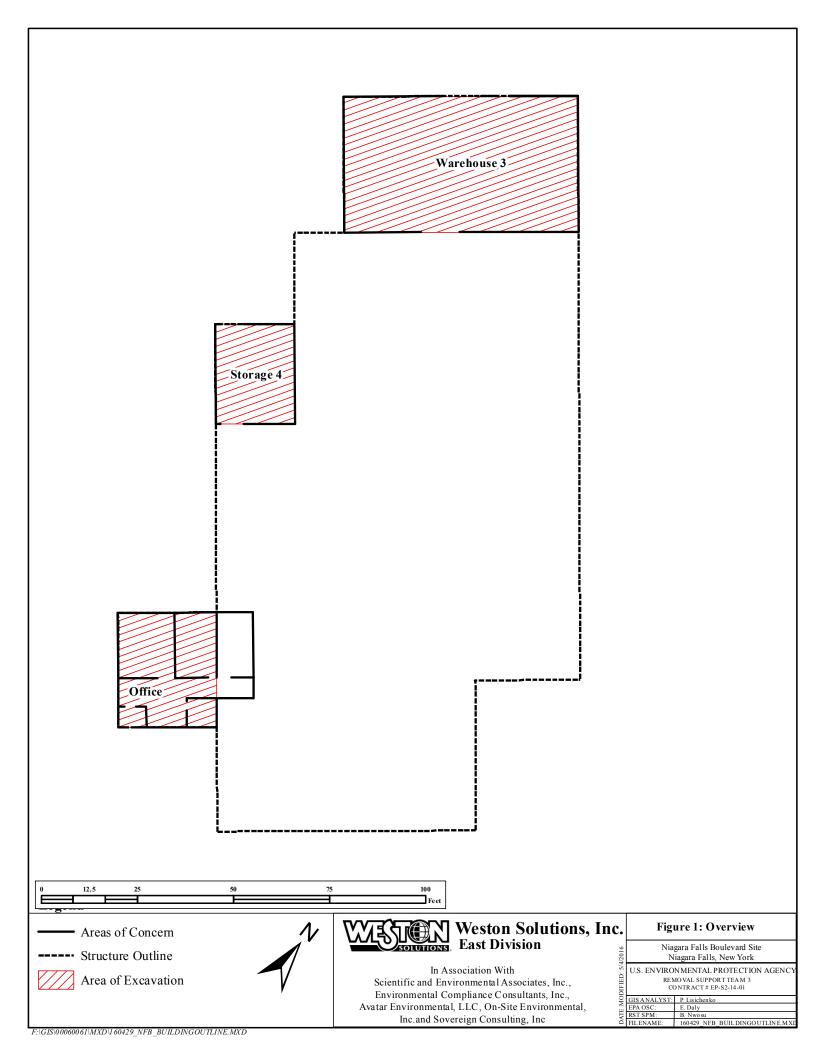
On April 27, 206, Weston Solutions, Inc. George Weaver (Structural Engineer) performed a structural evaluation of the building at 9540 Niagara Falls Boulevard, Niagara Falls, Niagara County, New York. Specifically, Mr. Weaver was tasked to determine the feasibility of removing portions of the existing concrete floor slab in the 9540 Niagara Falls Boulevard Building in order to remove contaminated soils below the slab. Three specific areas in the building were identified where the slab is to be removed: Office Area, Storage 4 Area, and Warehouse 3 Area (see attached Figure 1).

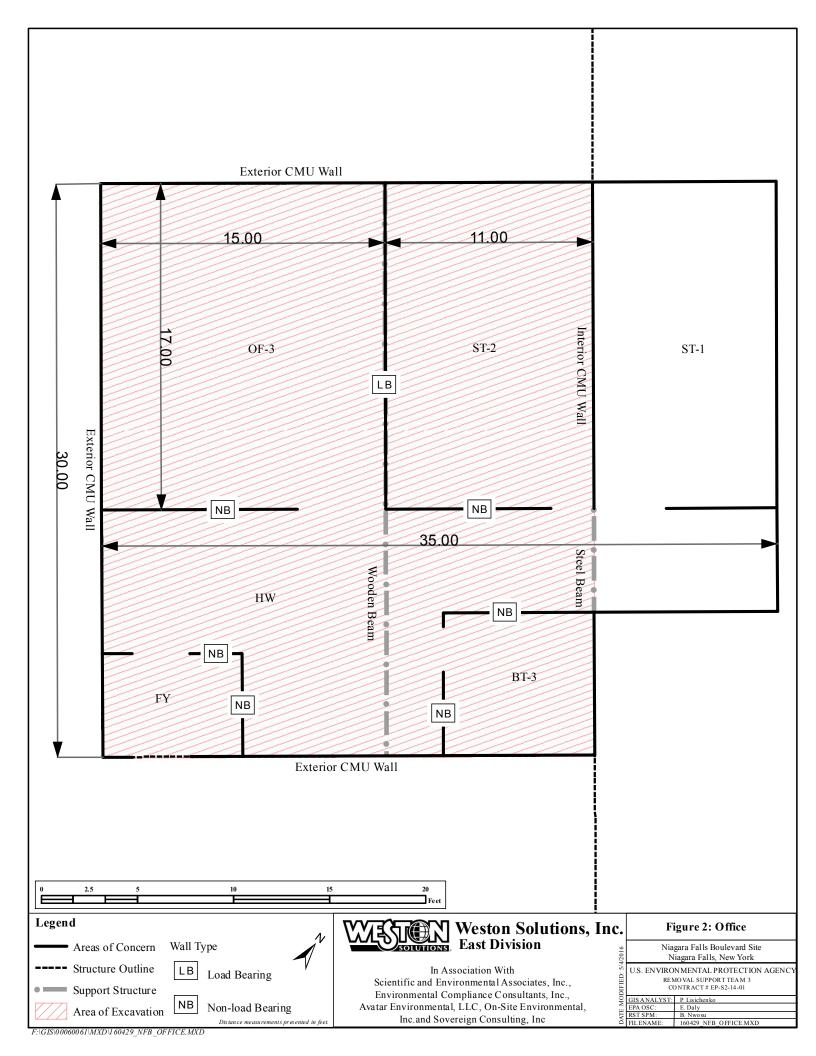
**Office Area** (see attached Figure 2)

Walls marked NB: Non-bearing, wood-framed interior walls that bear directly on the top of the floor slab. These walls can be removed.

Walls marked LB: Load-bearing, wood-framed interior wall that bears directly on the top of the floor slab. This wall supports the roof joists spanning in the E-W direction. Roof joists need to be shored prior to removing wall. Wall to be removed in sections to access slab and soils below the wall and new footing installed prior to moving on to another section of wall.

The exterior north, west, and south walls and the interior (former exterior) east wall are all CMU (concrete masonry units) walls. The bottom of these wall footings should be approximately 3'-6" below top of floor slab. Removal of the floor slab will not affect the these walls.

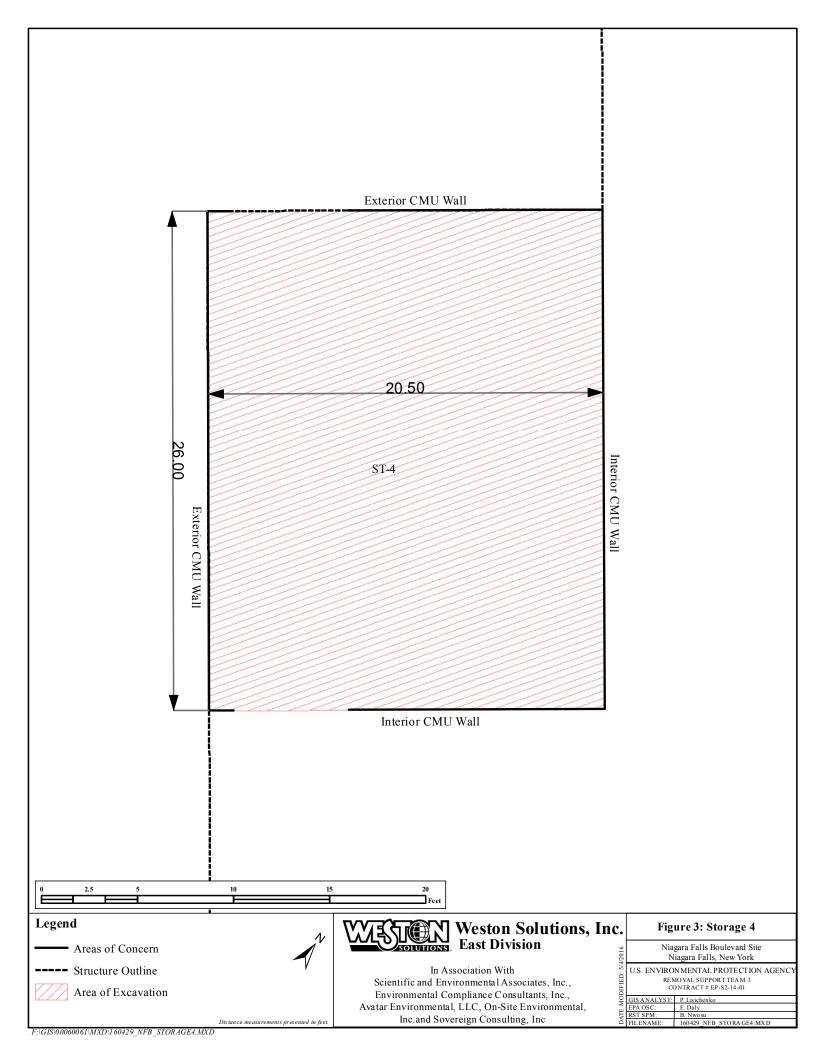
## **Storage 4 Area** (see attached Figure 3)

The exterior north and west walls and the interior (former exterior) south and east walls are all CMU walls. The bottom of these wall footings should be approximately 3'-6" below the top of the floor slab. Removal of the floor slab will not affect these walls.

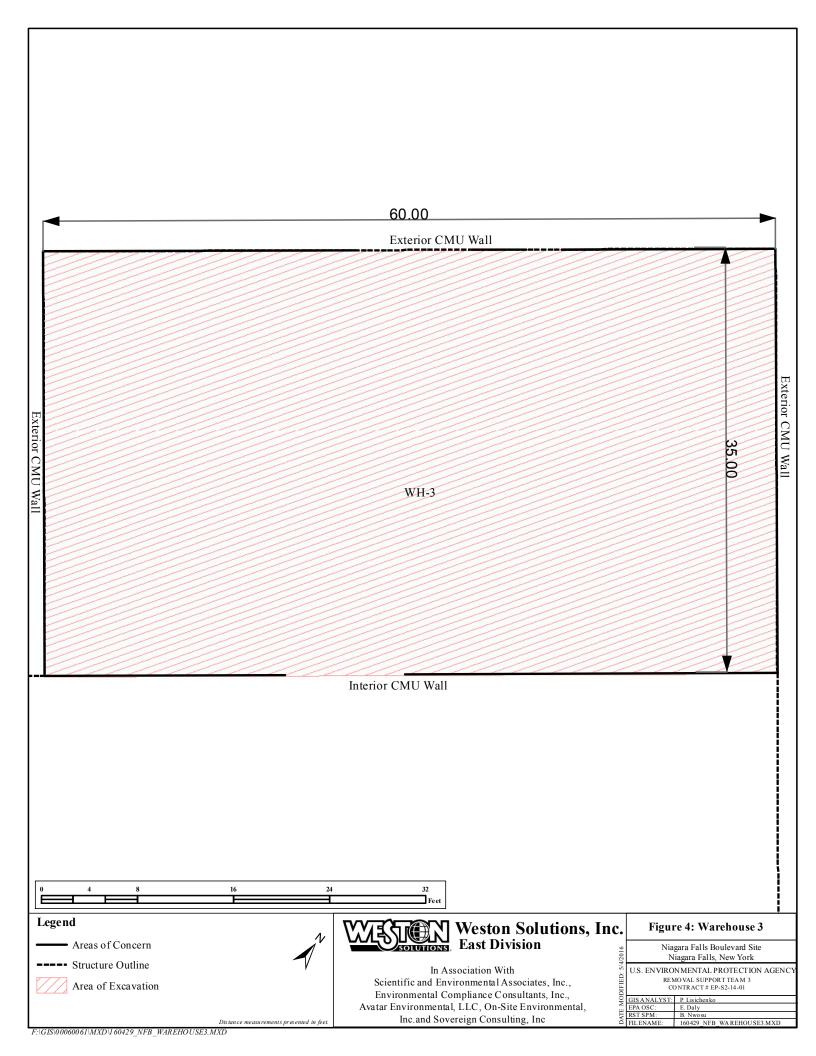
## Warehouse 3 Area (see attached Figure 4)

The exterior north, east, and west walls and the interior (former exterior) south wall are all CMU walls. The bottom of these wall footings should be approximately 3'-6" below the top of the floor slab. Removal of the floor slab will not affect these walls.
